Our **Technical Consultancy Services** extend beyond temperature performance, as shown in this example detailing our investigations concerning a humidification unit on a fresh meat counter.

FIELD SERVICE REPORT

| SUBJECT: | Meat Counter - Fogger | DATE: | 11th Jan 2017 |

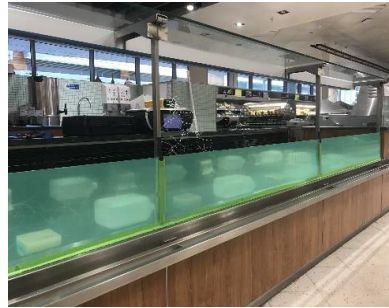
Counter fitted with temporary low screen

Example of test carried out to assess the impact on performance when a tall glass screen is replaced by a low glass screen to enable self service operation.

A full report & recommendations are issued upon test completion

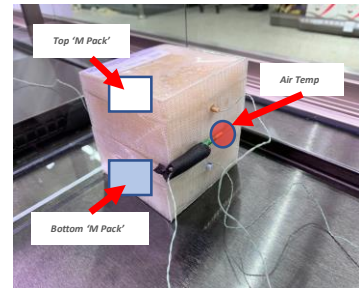
Test probe / M Pack arrangement

Test probe / M Pack location diagram

Tests can be conducted using 'M Pack' test packages (the EN standard test product), live products or air temperatures dependant on the requirements

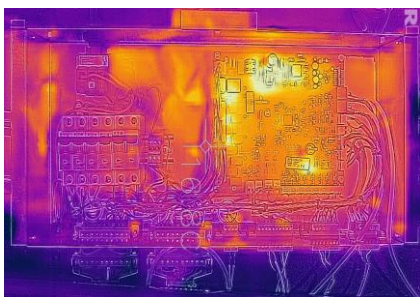
An typical assessment may be a refrigerated produce unit that was causing the ambient produce on the adjacent unit to spoil. The IR imaging (on right) identified that the internal baffle panels had been removed thus causing warm air to escape at low level.

IR imaging is also a great benefit when carrying out safety checks. Failing components or loose cables can easily be identified by their heat signatures as shown in the control panel (left).

Our RJM team carry a set of diagnostic tools to carry out airflow & temperature evaluations of troublesome or poor performing display units. In addition we can carry out Thermal Imaging assessments to identify issues & present them in a visible format.

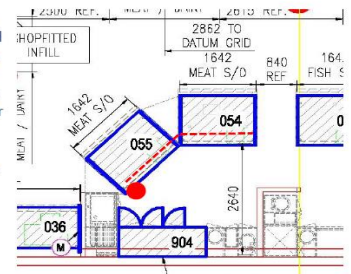
The humidifier unit is located at the RHS of sys 55 as indicated by the RED circle on the adjacent diagram.

Sys 54 was de-merchandised & after removal of the top discharge air grille the fog bar could be viewed. It is located in front of the evaporator coil directly behind the lower discharge air grille. There was little if any fog being produced from the entire 1.5m leg of fog bar beyond the 45 deg angle at the center of the overall counter.

Of immediate note was the fact that the fog bar had been installed with the outlet holes facing the direction of the cabinet airflow. (Refer to adjacent diagram - Fog show in **RED**, case airflow in **BLUE**) Past experience gives us the knowledge that the case fans can produce a pressure greater than the humidifier unit & therefore the fog will simply condense in the fog bar rather than be drawn out into the cabinet airstream. To prove this theory the case was stripped down & case fans turned off whilst the humidification unit was left running. Fog was evident along the entire fog bar length & velocity readings showed that the pressurization of the fog bar whilst not under the influence of the case fans was also uniform, indicating that the issue is related to the distribution of the fog rather than the production of fog.

In order to use the case fan to draw the fog out of the fog bar, the LHS section of fog bar was cut & rotated through 180 deg so that the outlet holes were in the same direction as the case airflow. A temporary joint was made to reconnect the fog bar. The counter was reassembled & fog was clearly visible within the cabinet airflow as it entered the counter along its entire length.

The humidifier unit appears to produce a sufficient volume of 'fog' however the design & orientation of the fog bar appears to be ineffective at distributing the fog into the cabinet airflow. The simple modification made by RJM would seem to greatly improve the amount of fog entrained within the airflow.

We recommend that a new fog bar is manufactured which incorporates holes to the front face & also drain holes to control the flow of any condensed water within the fog bar.
